Condition & Value Report of Marine Survey

1986 38 Island Packet Cutter

Scott Richard Berg, Principal Surveyor
SAMS® Surveyor Associate
CBW LLC © 2023 - All Rights Reserved

Date Of Survey: 10/23/2023 & 11/29/2023

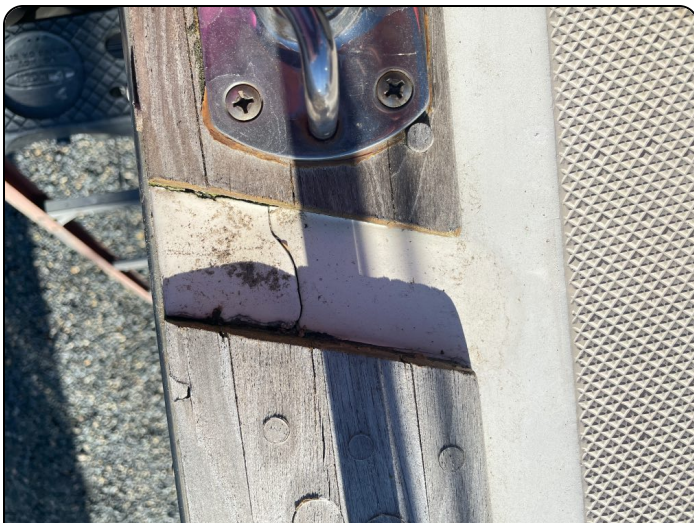
Unvarnished teak toe-rail; some teak glue up has failed, some bungs are missing, and some bronze fasteners have been replaced with stainless steel. Stainless steel isn't appropriate for use where it can not receive oxygen and is subject to moisture buildup. This is a cosmetic issue and goes to maintaining value and is not considered structural or safety related.

Crack in cap rail and teak toe rail

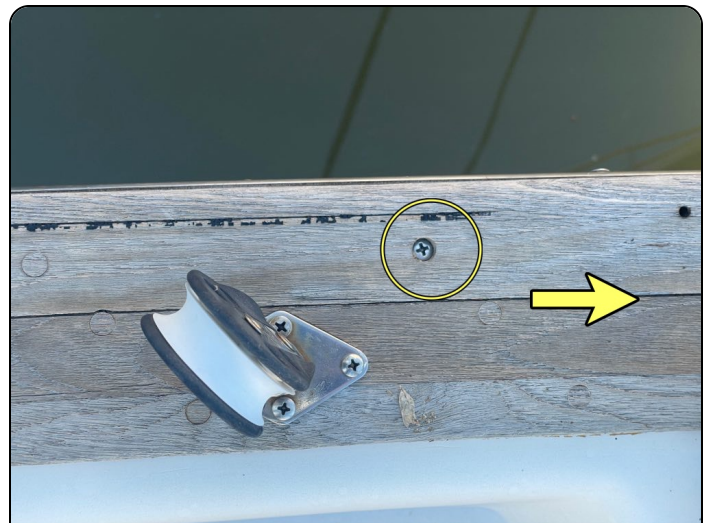
Incorrect fastener and crack in teak glue joint

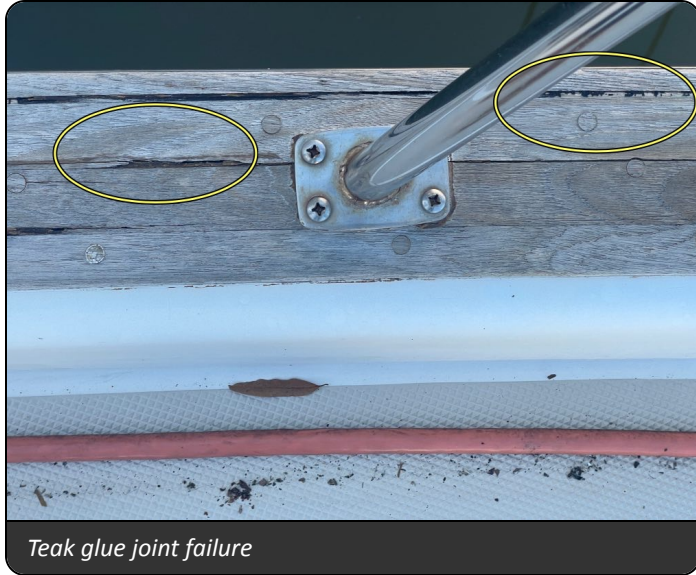
Teak glue joint failure

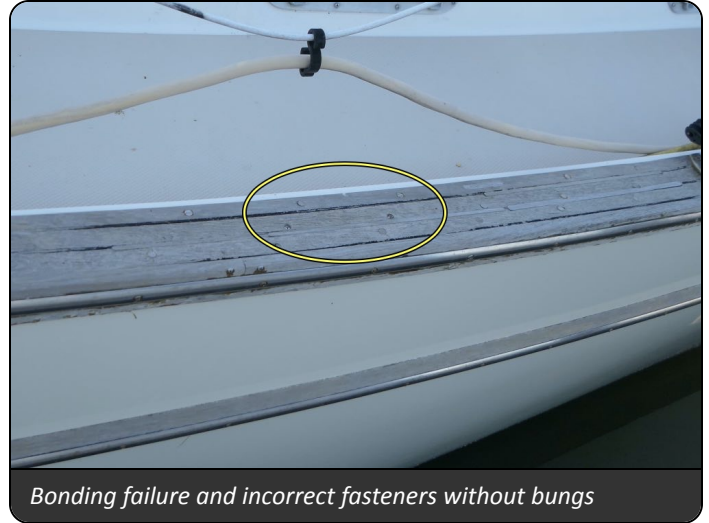
Bonding failure and incorrect fasteners without bungs

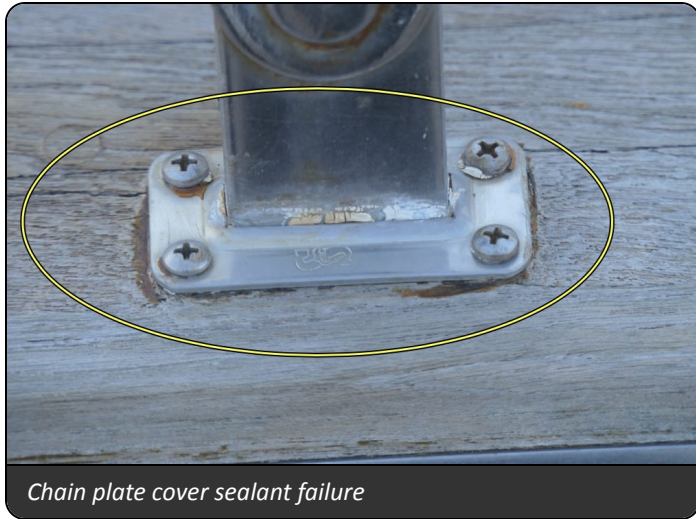
No significant weathering was observed on the vessel's exterior caulking sealants except as noted. Specifically, the chainplate covers show a loss of elasticity; this can lead to chain plate failure, a known issue with pre-1996 Island Packets. See notes under chain plates.

Chain plate cover sealant failure

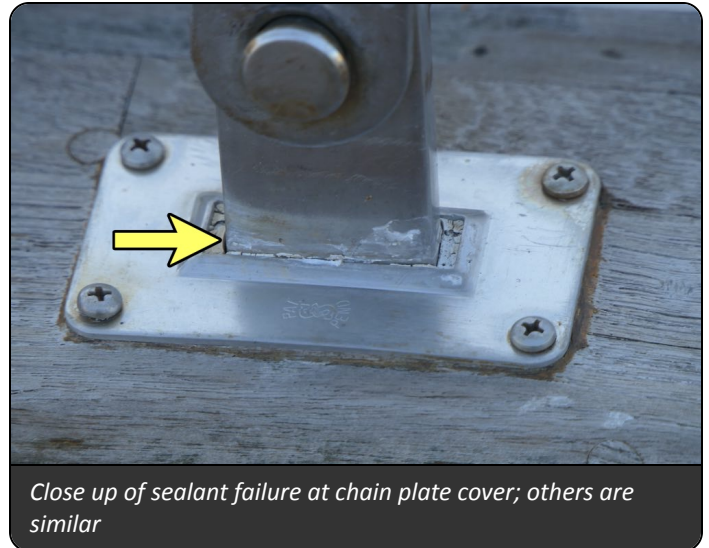
Close up of sealant failure at chain plate cover; others are similar

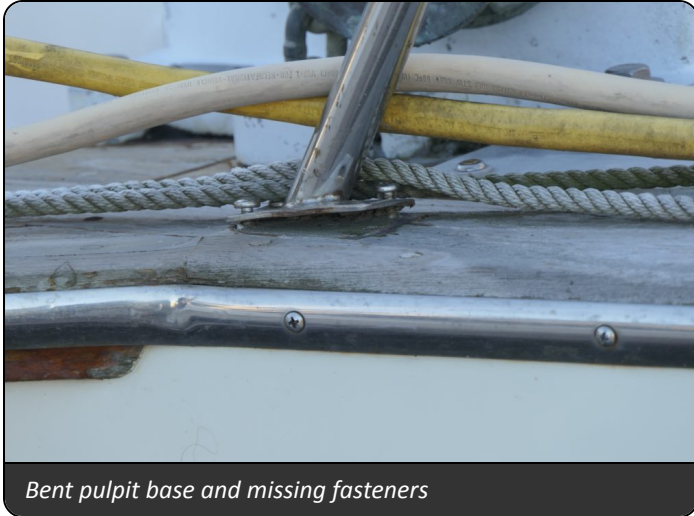
1" Stainless steel pulpit; several of the mounting feet are bent, dislodged, and missing fasteners

Bent pulpit base and missing fasteners

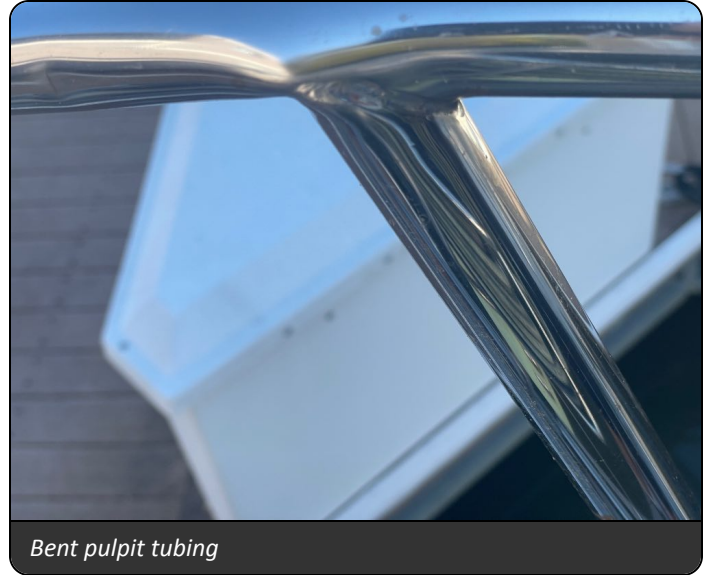
Bent pulpit tubing

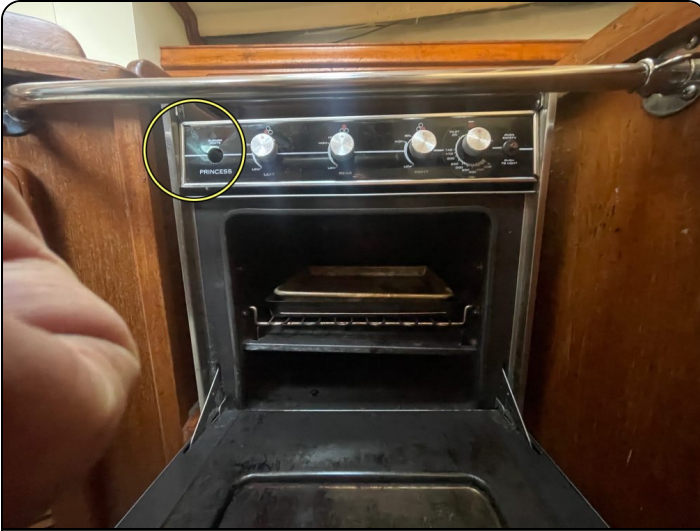
Princess Stove, burner ignition was missing; burners were operational when lit with lighter but oven was not tested.

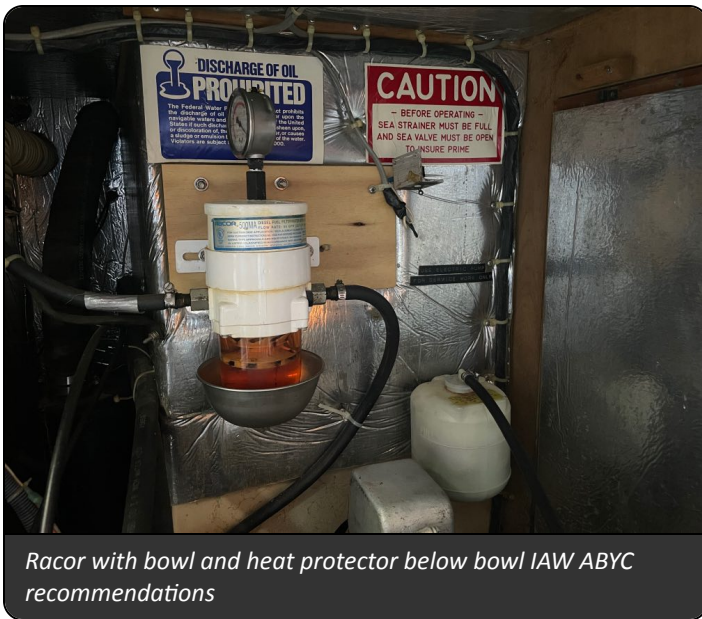
Racor with bowl and heat protector below bowl IAW ABYC recommendations

Sediment & algae was observed in the Primary fuel filter's sight bowls and on their diffusers. Monitor/service often.

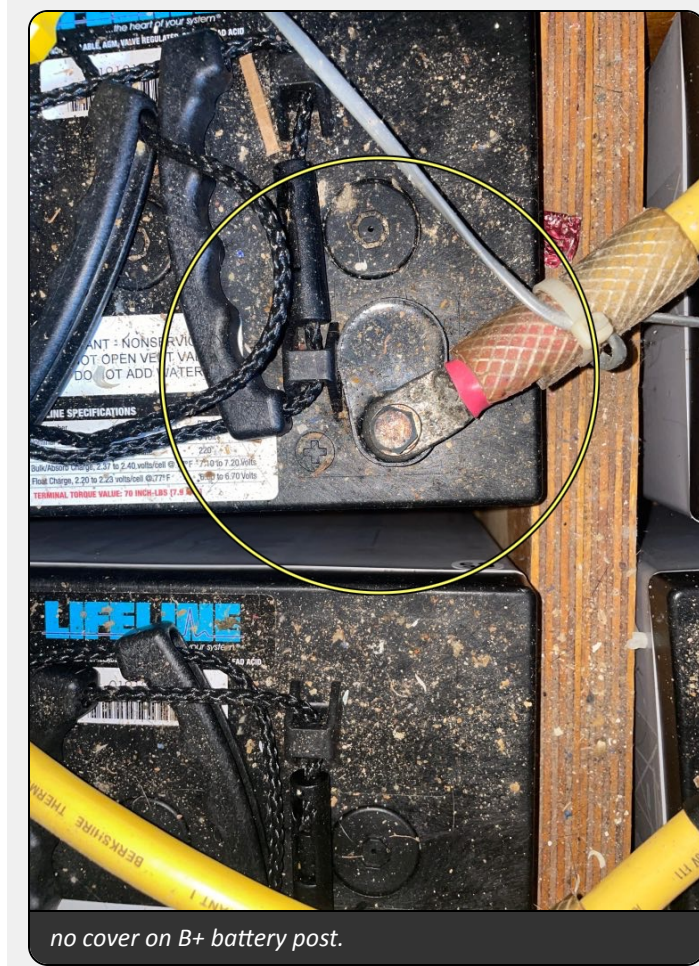
no cover on B+ battery post.

Properly secure batteries, and install protective terminal insulation covers to prevent accidental shorting, as necessary.

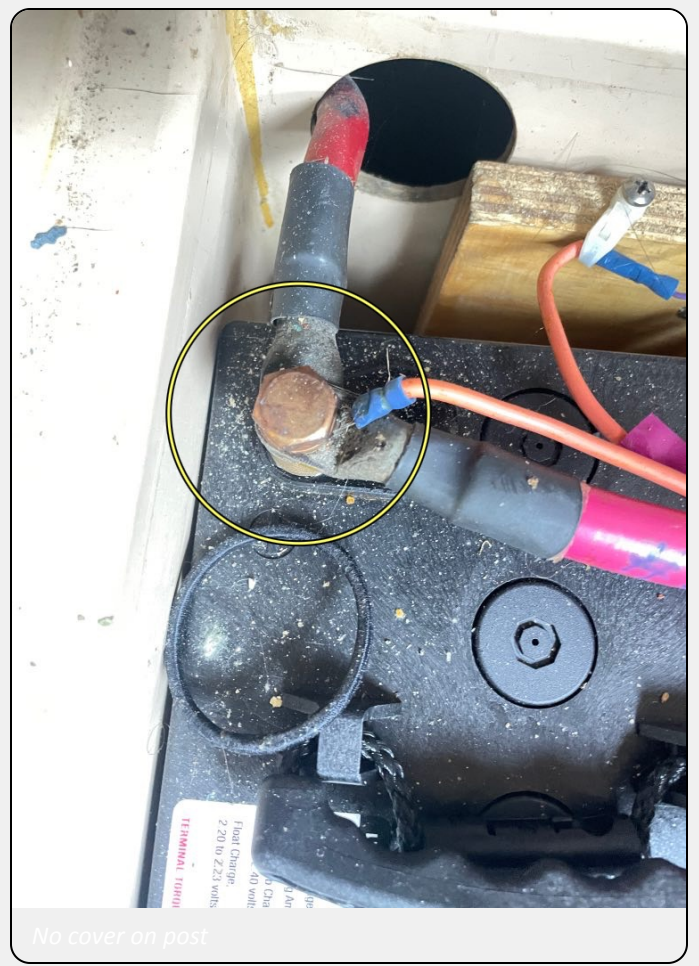
No cover on post

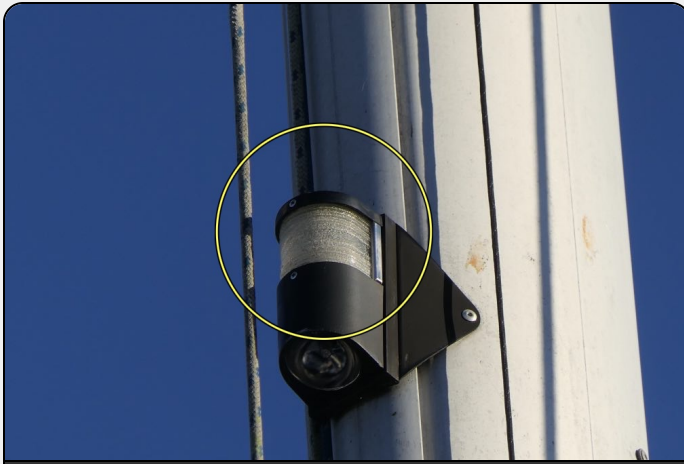
Check lamp in Masthead light

Repair or replace the Navigation Running Lights to comply with USCG Regulations.

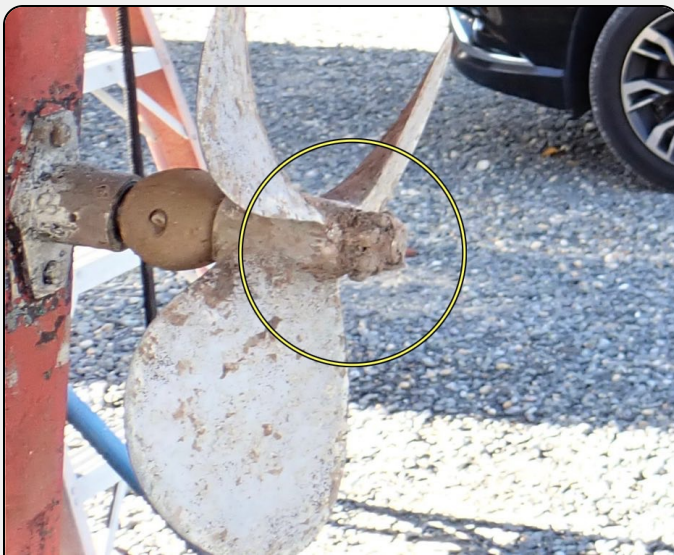
Propeller nut area showing fouling

Investigate further, and service/clear debris as necessary.

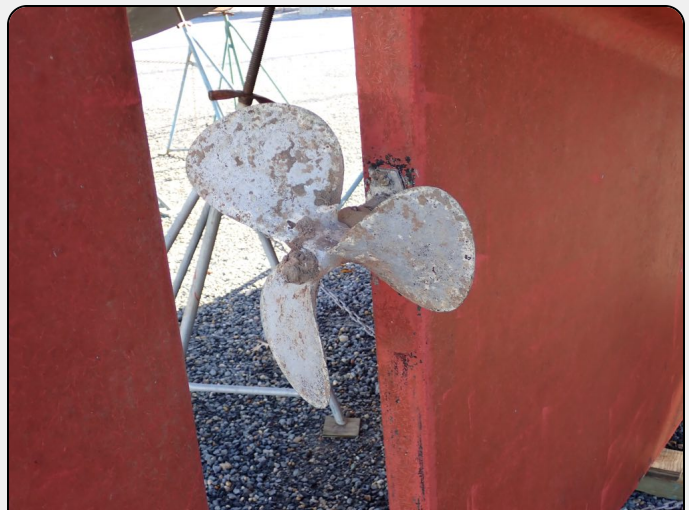
Propeller shows no signs of damage but should be cleaned and conditioned as needed.

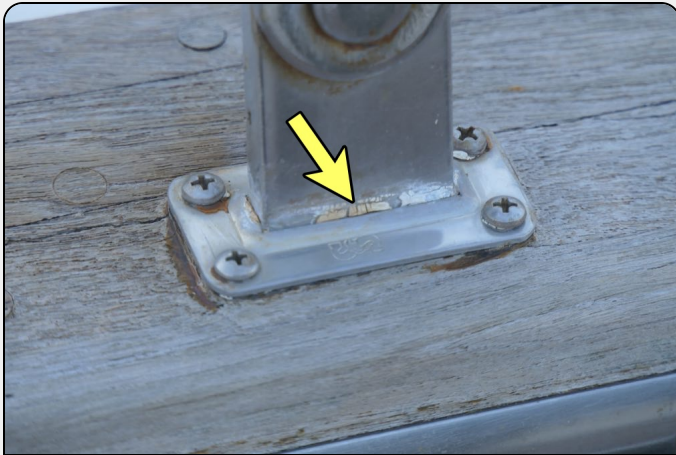
Sealant failure

Investigate further, and service, repair or replace as necessary.

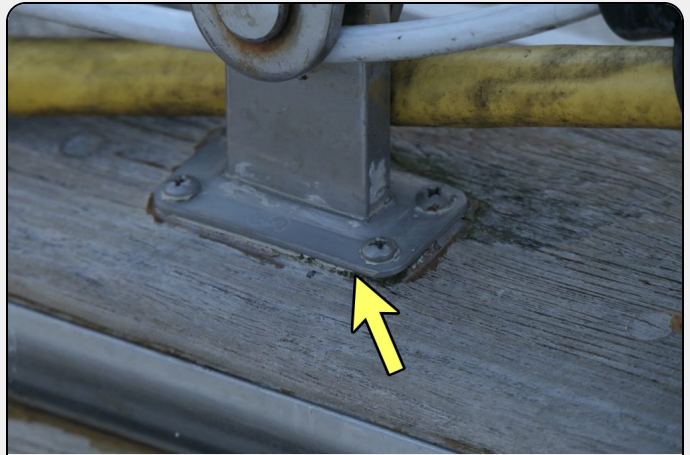
Cover lifting from cap rail

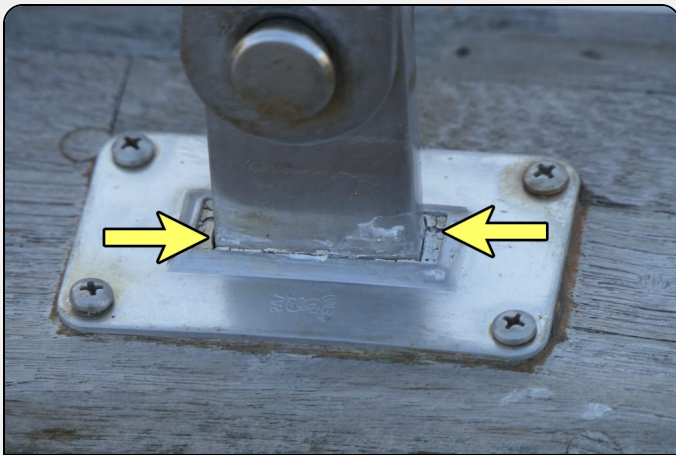
Sealant failure

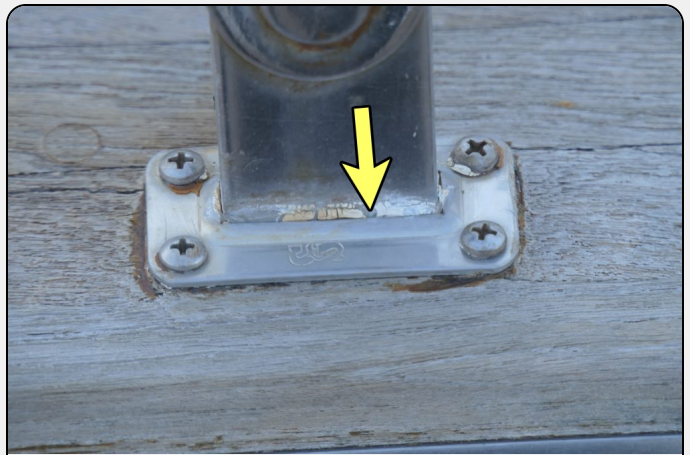
Sealant Failure

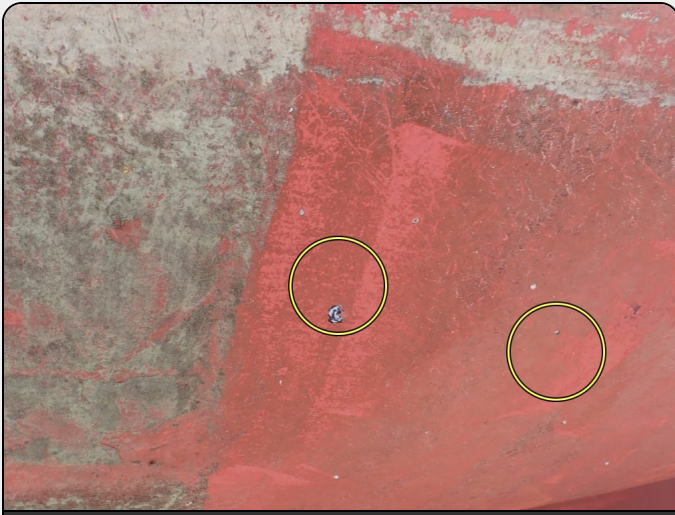
PORT Side Forward

The hull blisters noted in the BOTTOM section of this report are currently cosmetic in nature and pose no structural risk. They should be monitored and attended to on a future haul out to maintain the vessel's value.

Investigate further, and repair in accordance with good marine practice as necessary. Repair the blisters, as necessary. Also recommend applying an Epoxy based Barrier Coating System.

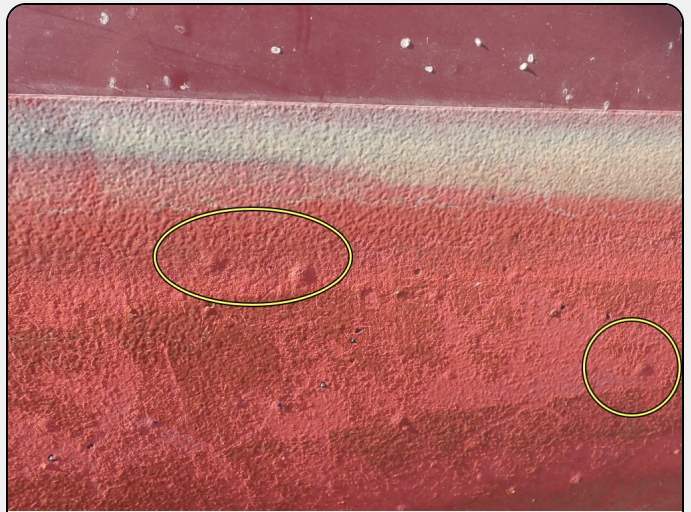
Marking some of the blisters

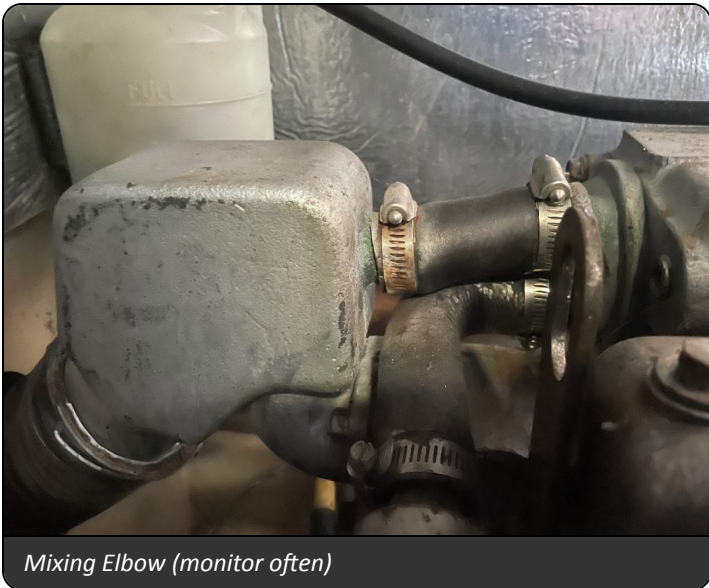
Mixing Elbow (monitor often)
