2001 34 Mainship Pilot Sedan

Report of Marine Survey

09/15/2023

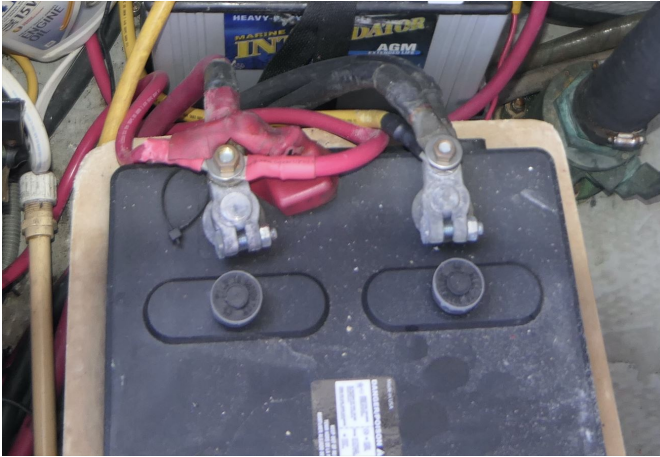
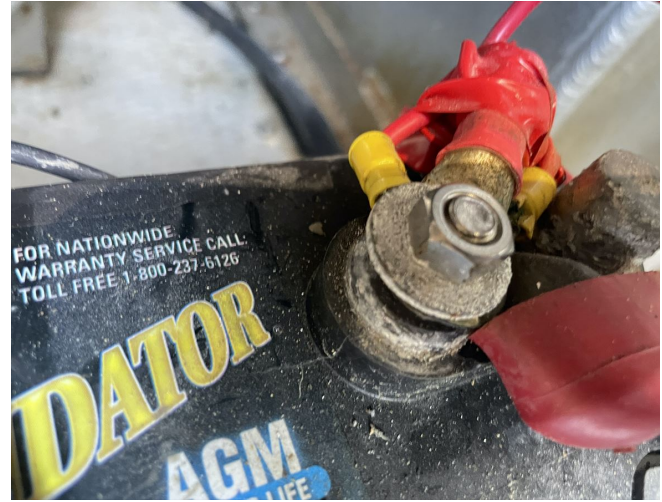
FINDING A-2 BATTERY CHARGERS

No overcurrent protection for the battery charger conductors was observed at the batteries
