## 2000 Beneteau 411

# Pre-Purchase Report of Marine Survey

2000 Beneteau 411

**Date Of Survey:** October 28, 2024  
**Report Submitted On:** November 1, 2024

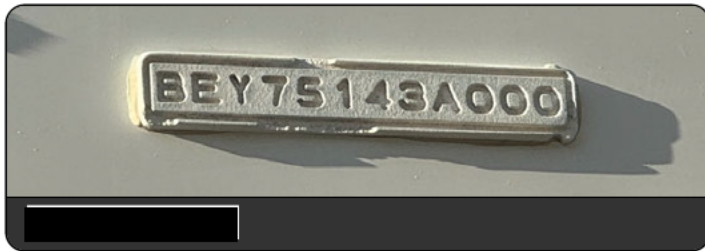
#### HIN (HULL IDENTIFICATION NUMBER) COMPLIANCE (33 CFR 181)

The vessel's HIN (Hull Identification Number) displayed on the starboard transom matched the HIN recorded on the State Title.

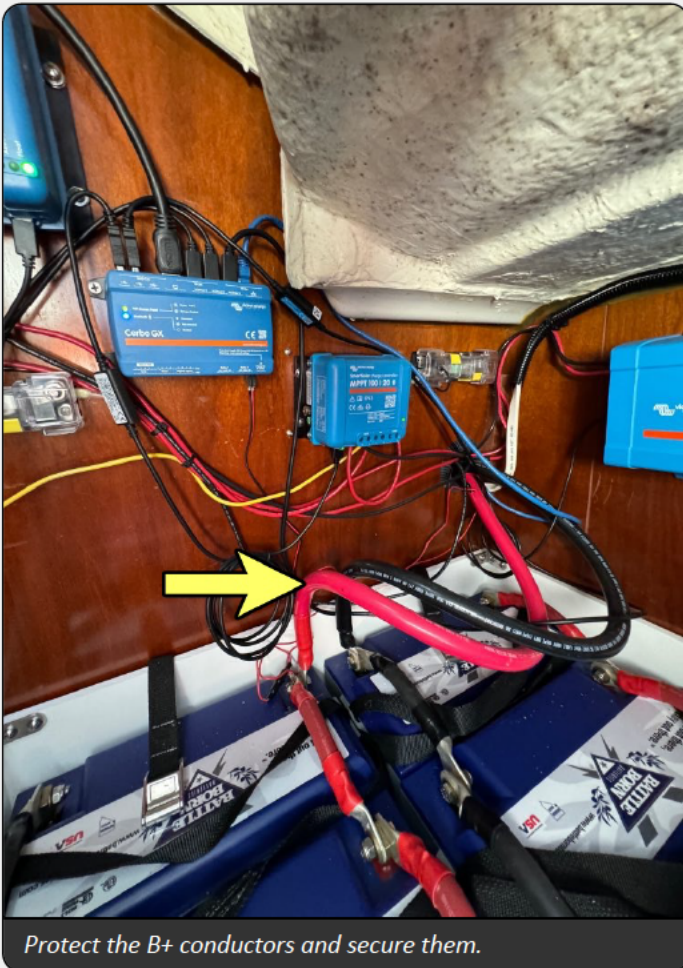
Install a fire protective sheath over the ungrounded battery cabling between the bank and the T Fuses IAW ABYC E-11.10.1.1.1 (see Exception 2 below) "Overcurrent Protection Device Location - Ungrounded conductors shall be provided with overcurrent protection device(s) within a distance of seven inches (178 mm) of the point at which the conductor is connected to the source of power measured along the conductor"

EXCEPTION 2: "If the conductor is connected directly to the battery terminal and is contained throughout its entire distance in a sheath or enclosure such as a conduit, junction box, control box, or enclosed panel, the overcurrent protection shall be placed as close as practicable to the battery, but not to exceed 72 in (183 cm)."

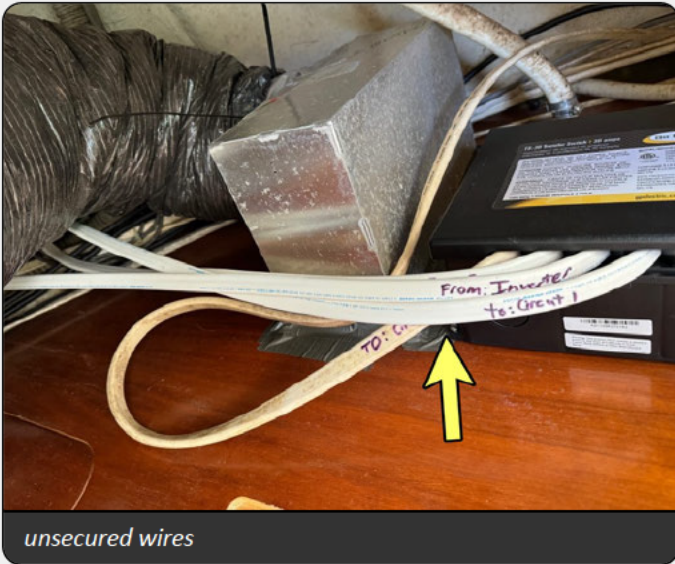
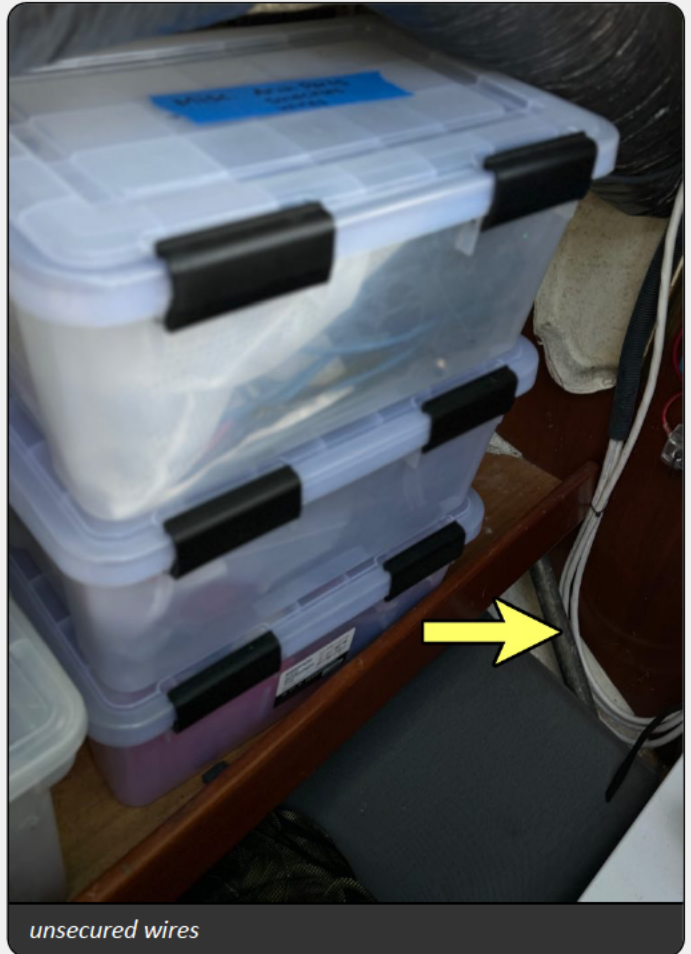
**FINDING B-2 ELECTRICAL SYSTEMS :: AC ELECTRICAL SYSTEMS : SECURING**

Wires in the STB locker and Lazerette were not secured to bulkheads or other acceptable locations

Secure all wiring every 18" IAW ABYC E 11.15.4.1.9

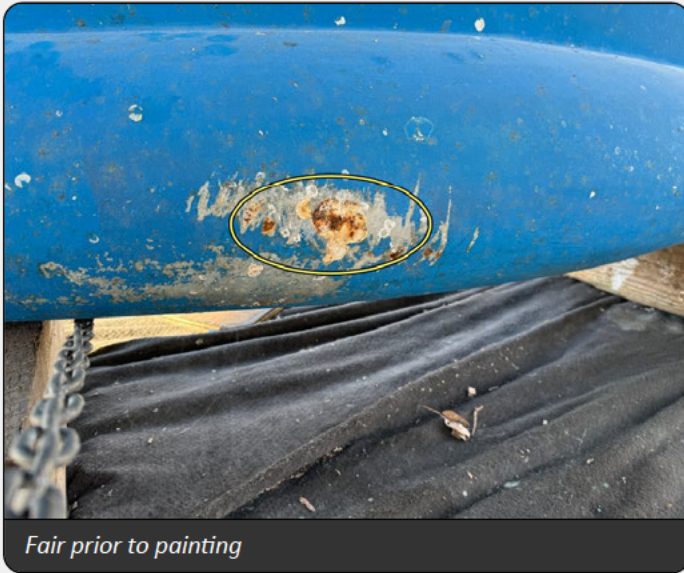
Cast iron keel with bulb in serviceable condition. The STB leading edge of the keel should be repaired prior to bottom paint.

Repair the keel bulb prior to applying antifouling paint.

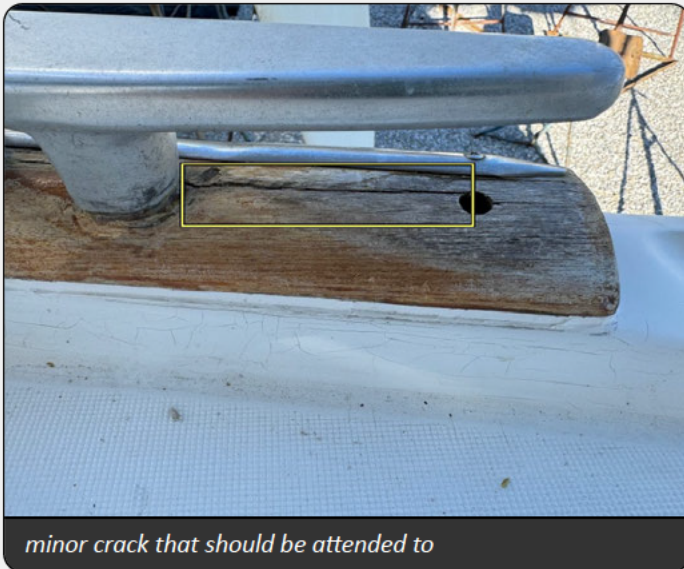
**FINDING C-2 VESSEL CONSTRUCTION :: DECK ARRANGEMENT : TOE-RAILS**

Teak caprail in serviceable condition. There is a small crack on the AFT corner of the STB rail at the cleat.

There is a longitudinal crack approximately 6" long on the AFT Cap Rail to STB and a bung is missing.

Repair the rail and replace the bung as necessary.

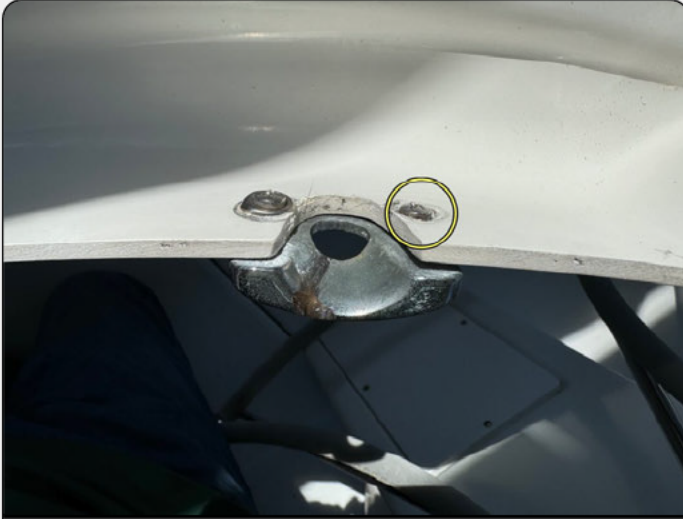
There were four (4) exterior lockers and storage areas in the cockpit including the former LPG locker (unused as the system was removed). All appeared serviceable, where sighted. The AFT lazarette locker latch fastener had pulled through the glass and should be repaired with a new washer and bolt.

*screw head pulled through; add washer and refasten*

Replace the fastening as needed.

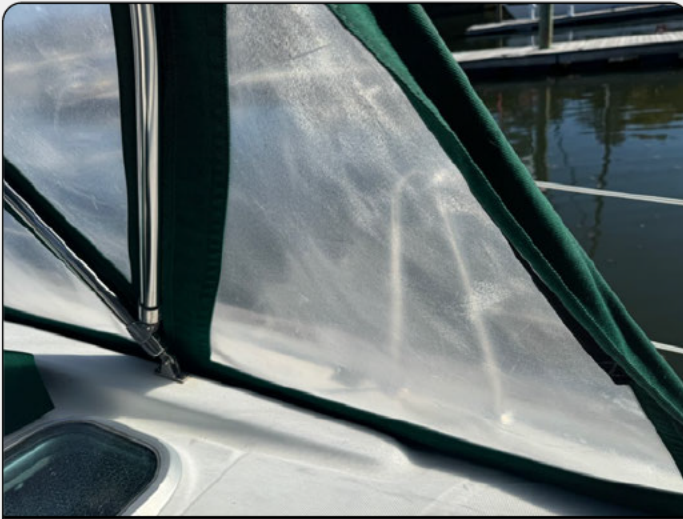
**FINDING C-5** EXTERIOR EQUIPMENT : COCKPIT CANVAS

There is a companionway dodger and bimini top over the cockpit with a joining piece to create a full enclosure. The Sunbrella type material is in good condition but some of the isinglass windows are clouded and should be replaced in the next two years (sooner for purely cosmetic reasons)

*Some clouding on the isinglass*

In the next two years replace the isinglass as needed
