## 2021 28 Cutwater 28 LE

# Report of Marine Survey

2021 Cutwater 28 28 LE

**Date Of Survey:** August 30, 2024

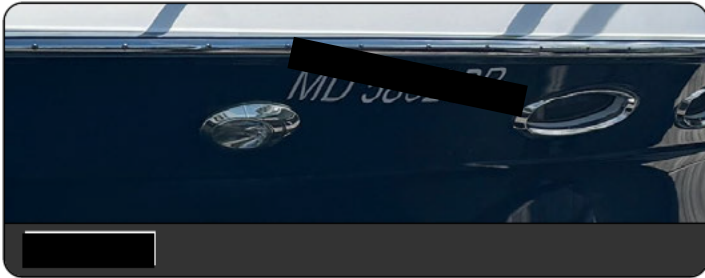
**FINDING A-1**

The vessel's State Registration Numbers were displayed. No MD Decal was displayed, and the registration was reportedly expired.

Renew and display as required for compliance as necessary.

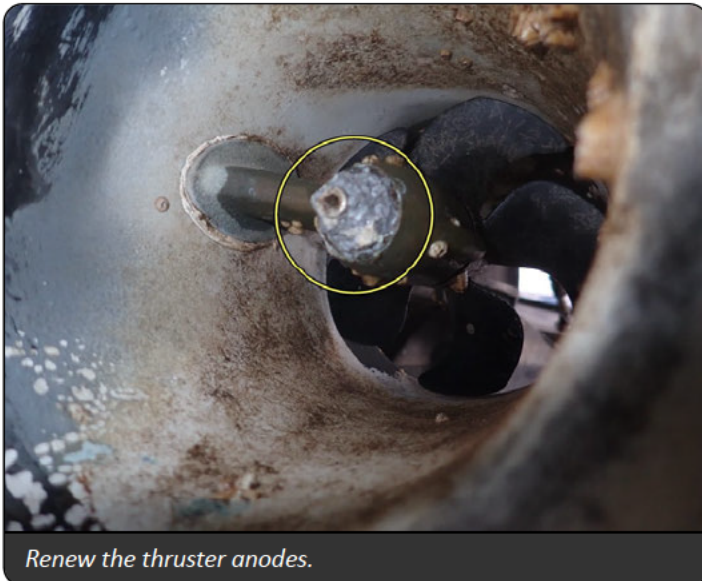
There were no anodes on the shaft or trim tabs as the boat was kept on a lift. The anodes on the thrusters were wasted and in need of replacement.

-400mv. This low reading is caused by having no sacrificial hull or shaft anodes. If the vessel is stored in the water they should be installed (see Findings)

*Renew the thruster anodes.*

Replace the wasted Zinc Anodes to ensure proper electrolytic corrosion protection.

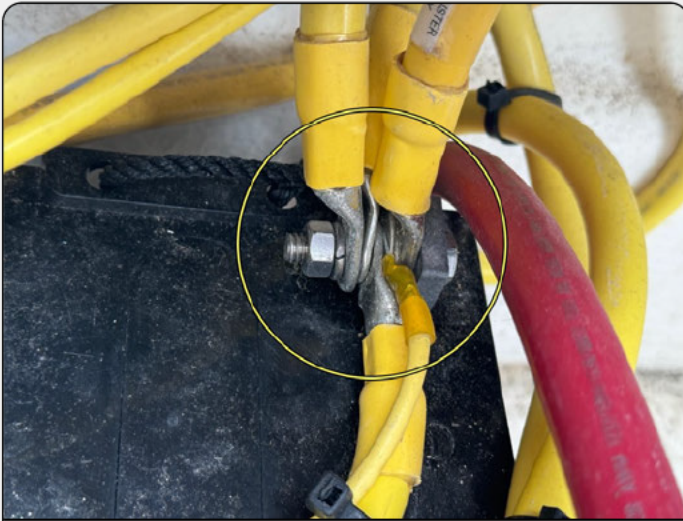
*Correct # of terminals and order of connection*

Correct the wiring with no more than four (4) correctly ordered terminals on each post or stud IAW ABYC E-11.

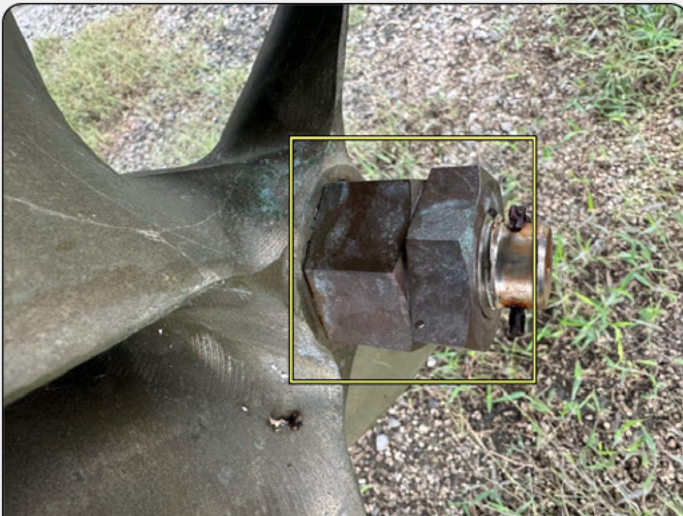
One Bronze 4 blade propeller; no dings or other damage was observed. {NOTE} Prop nuts were installed in reverse order; thin nut on back of thick nut. The propeller nuts should be installed with the heavier nut (thicker) behind the smaller (thinner) nut.

*Nuts are reversed and cotter pin should be renewed.*

Correctly refit the propeller nuts to comply with ABYC Standards at the next haul out. ABYC P 6 Ap. 6.2, SAE J755 (thin nut in front and thick nut behind) and replace the cotter pin with properly sized SS one.

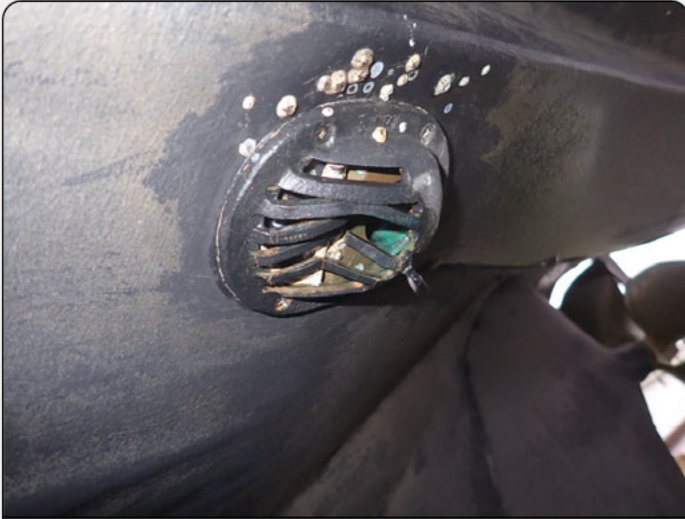
**FINDING B-7 UNDERWATER EQUIPMENT & HULL INSPECTION : HULL SEA-STRAINERS**

The PORT sea strainer scoop had missing slots.

*Replace the scoop at the next haul out*

Replace the scoop, as necessary.

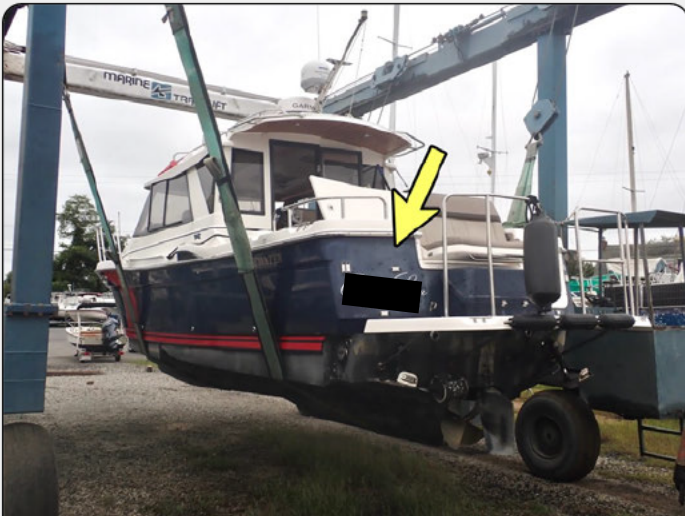
Blue gelcoat with a red boot stripe. The vessel finish was in very good condition, with the exception of the transom.

*The transom finish was not as clean and polished as the rest of the hull.*

Clean, compound, and polish the hull, especially the transom, as needed.

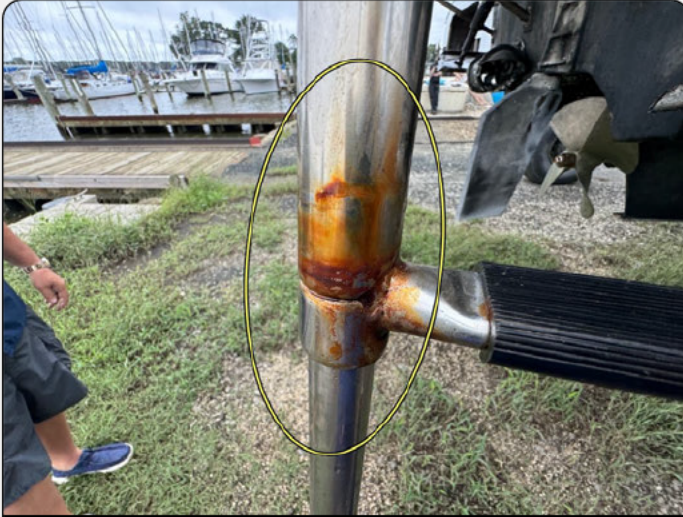
The aft swim ladder has some surface corrosion and should be cleaned and polished for both smooth operation and appearance

*Clean and polish*

Clean and polish the ladder as necessary.

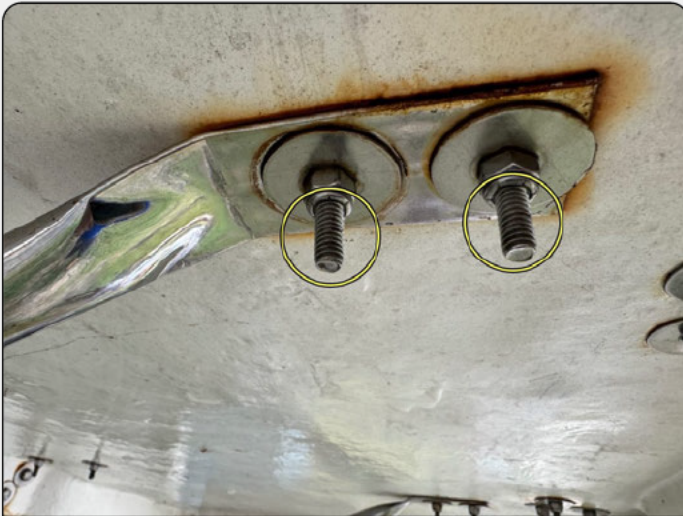
**FINDING C-3 VESSEL CONSTRUCTION :: HULL ARRANGEMENT : SWIM PLATFORM**

*Bolts could pose a hazard and should be shortened or covered.*

Shorten the nuts or otherwise protect the protruding ends as necessary.

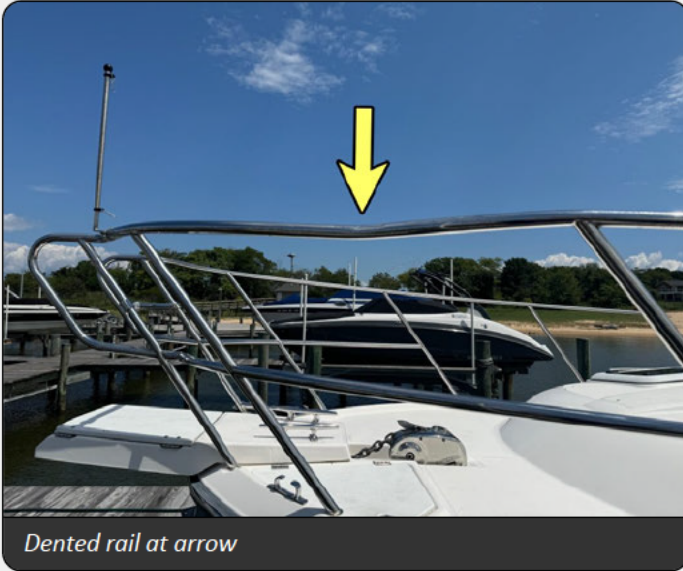
**FINDING C-4 EXTERIOR EQUIPMENT : DECK RAILINGS**

There is a forward deck railing and integrated pulpit (1" SS) and stern rails and swim platform rails (1.25" SS). All are in serviceable condition. There is a dent on the FWD PORT Rail.

*Dented rail at arrow*

Have a rigger correct the bend and polish the rail as desired.

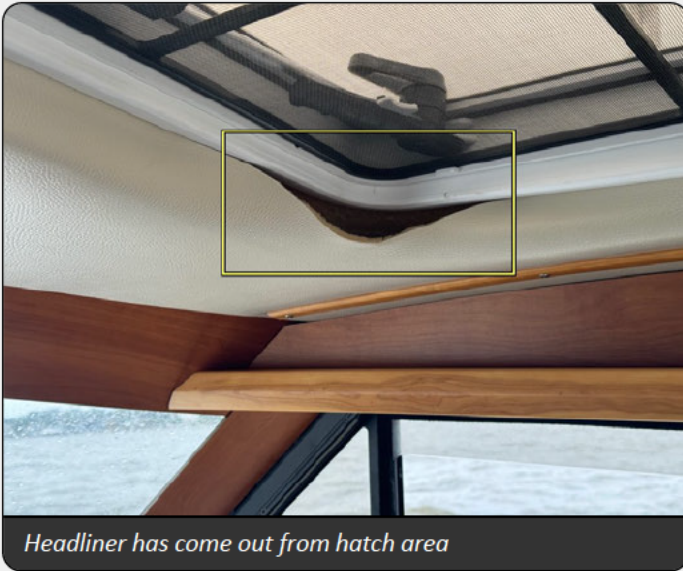
Some of the interior cabin headliner has come loose at the hatch over the helm area

*Headliner has come out from hatch area*

Refit the headliner trim, as necessary.
