ELECTRIC SHOCK DROWNING

The Truth Behind the Tragedies

A compilation of technical articles from EC&M

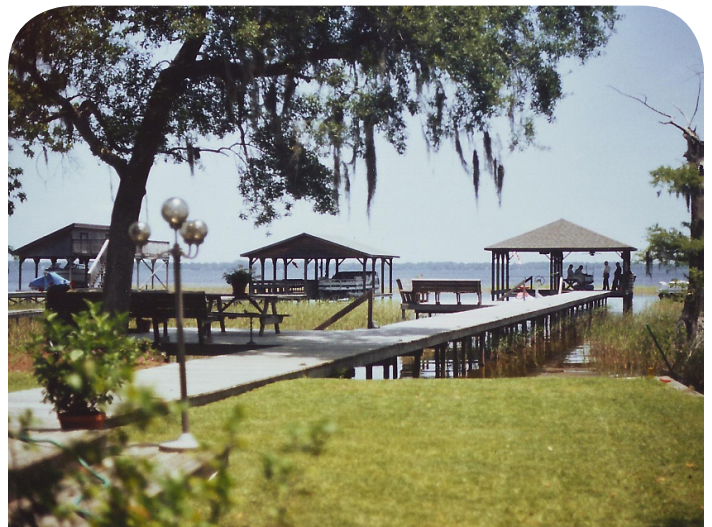
Photo 1. The boat dock on the far right is where the accident occurred. The wiring to the dock is routed on the opposite side of the walkway.

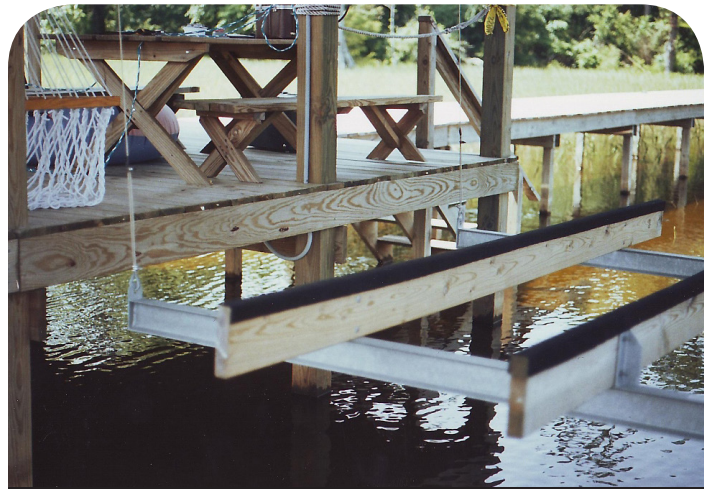
Photo 2. This image is of the boat lift assembly that was energized, with the metal rails visible, attached to the metal wires.

When the grandfather lifted the rails out of the water, he disconnected the leakage path, allowing the electricity to remain on the rails. Unfortunately, when the boy hung from the rails with his feet in the water, he provided a direct path for current to flow.

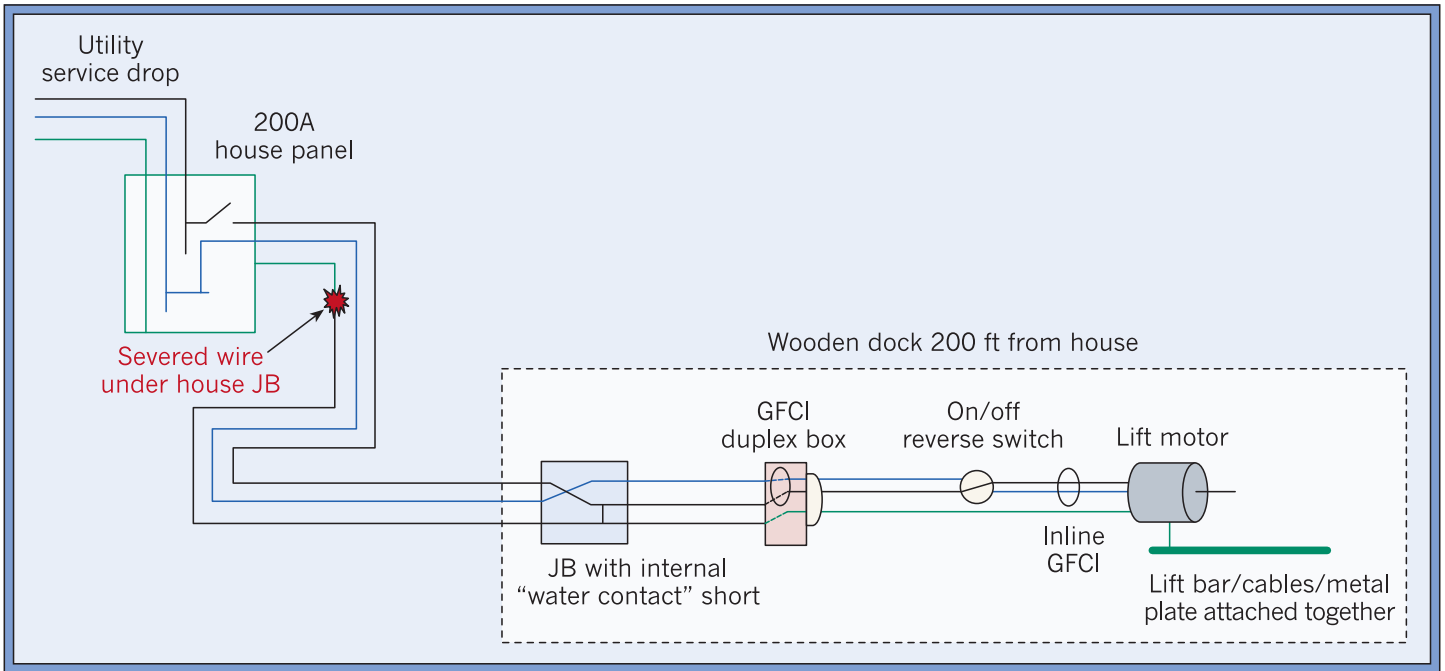
Fig. 1. This electrical schematic indicates the relative location of the severed wire under the house to the dock.

The dock was fed by a UF (underground feeder cable) 12-2 rated cable with ground, which was routed from a junction box located in the house's crawl space (**Fig. 1** and **Fig. 2**). A UF cable is suitable for direct burial in the

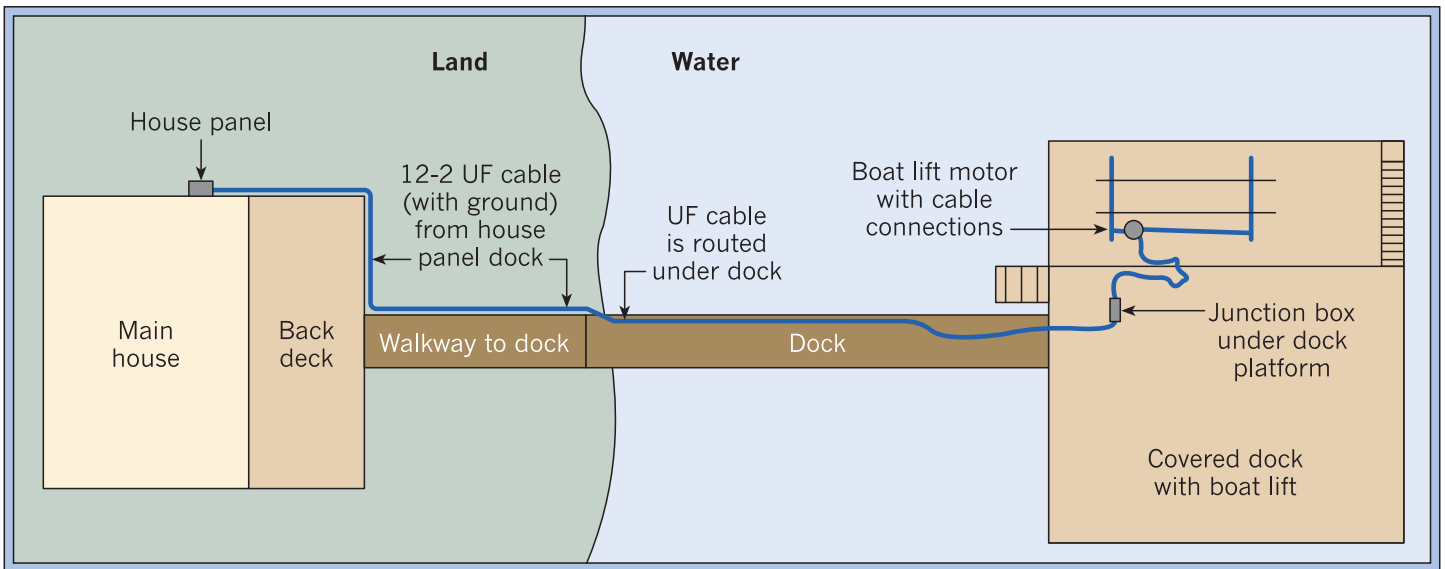
Fig. 2. Overhead view of the area allows you to see the full path of the electrical circuit.

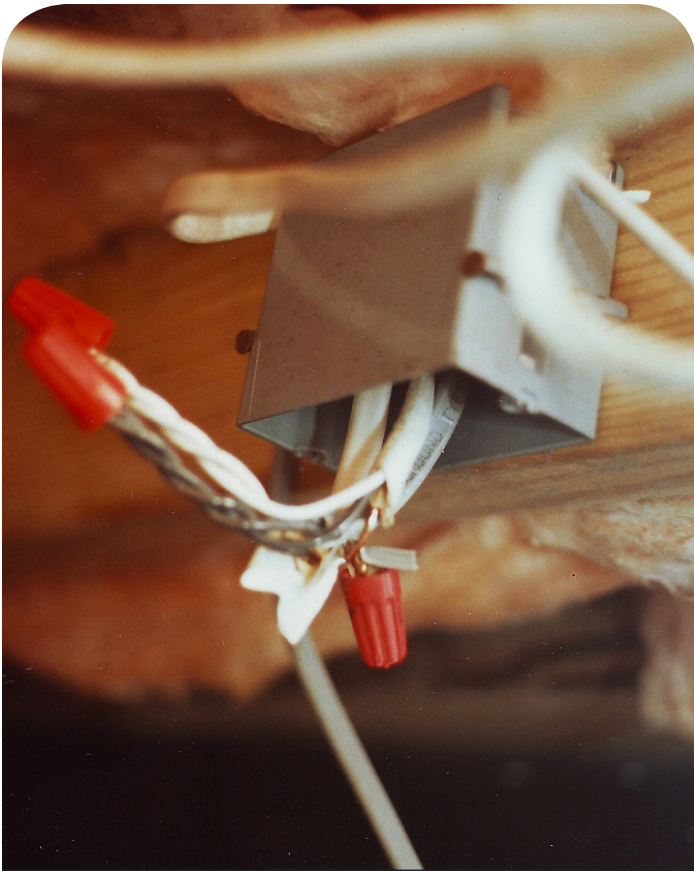
Photo 3. This image identifies the junction box found with the severed ground wire. Note the red wire-nut on the shortest wire, which is ground.

a shorter ground wire. I later learned from the town's electrical inspector that he had found this wire hanging out of the junction box, and it was severed at that point (**Photo 3**). Upon seeing this, he had reconnected it, to prevent any other ground issues.

The inspector stated that the dock was originally built without electricity, and whoever did the wiring never obtained an electrical permit. The grandfather recalled that a local contractor had completed the work, and did not recall if he had seen the permit (the dock had a certificate of occupancy but without electricity). I surmised there was no telling how long that ground wire had been severed.

The recommendations. First of all, an electrical permit should have been obtained by the electrician. The inspection would have uncovered the missing GFCI at the house, and the connection under the house would have been installed to NEC regulations, preventing the

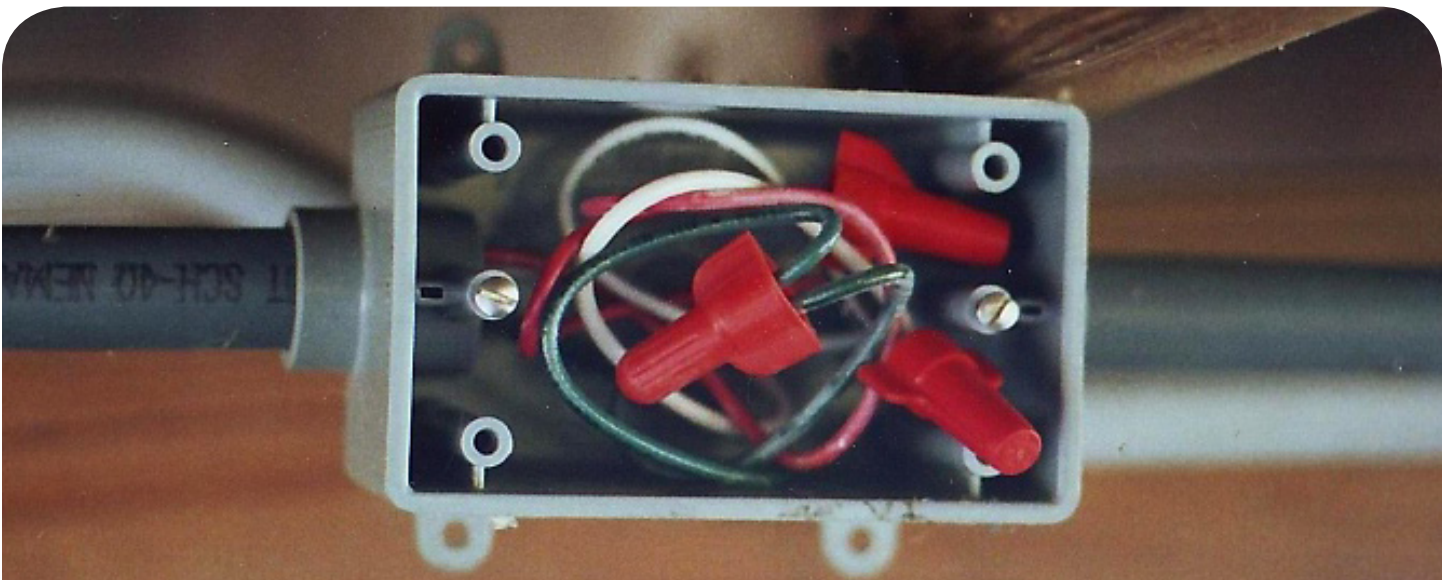
Photo 4. This image is of the under-deck plastic junction box with plastic conduits emerging on both sides. Water was released from the box when the inspector opened it.

motor and were spliced to the house wires with wire nuts. When he removed the cover screws, water poured out of the box. He identified that the ground (green) wire and the phase (black) wire of the 120V UF cable were on the bottom of the box. I noticed a line on the inside of the junction box, suspecting that this was identifying the water level inside the box, with the two wires clearly being below the line (**Photo 4** on page 15).

The quirky piece of this puzzle is that individually the severed ground wire and the water buildup would not have caused this fatality. But together, a dangerous electrical condition was lurking under the surface, waiting for someone to provide the grounding connection.

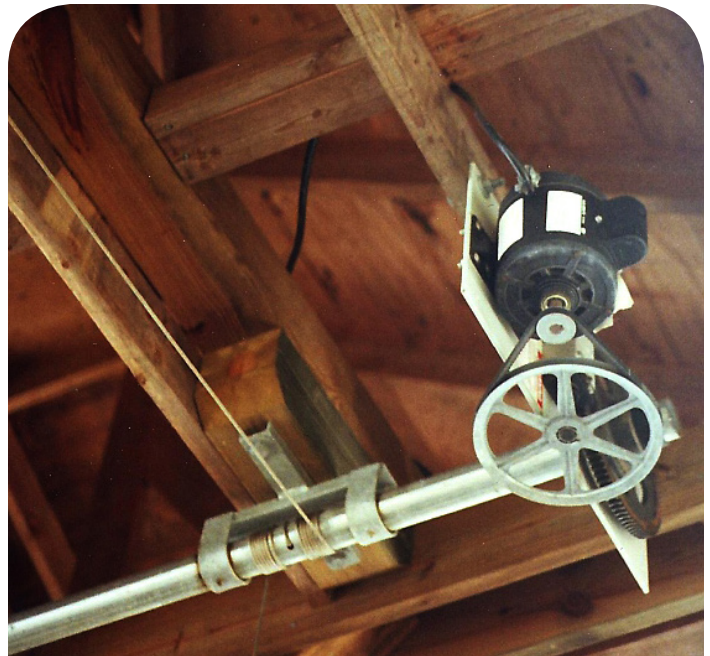
Photo 5. An image of the lift motor mounted on a metal plate, attached to the metal rod with the metal wires that are attached to the metal lift rods in Photo 2.

to be a useful clue in the case. Occasionally having a problem activating the boat lift, the grandfather said it had appeared sluggish to start and made buzzing noises in the past. This made me think that at these moments, the motor might not have been receiving sufficient voltage due to leakage into the lake; therefore, it could not turn the motor shaft to drive the boat lift.

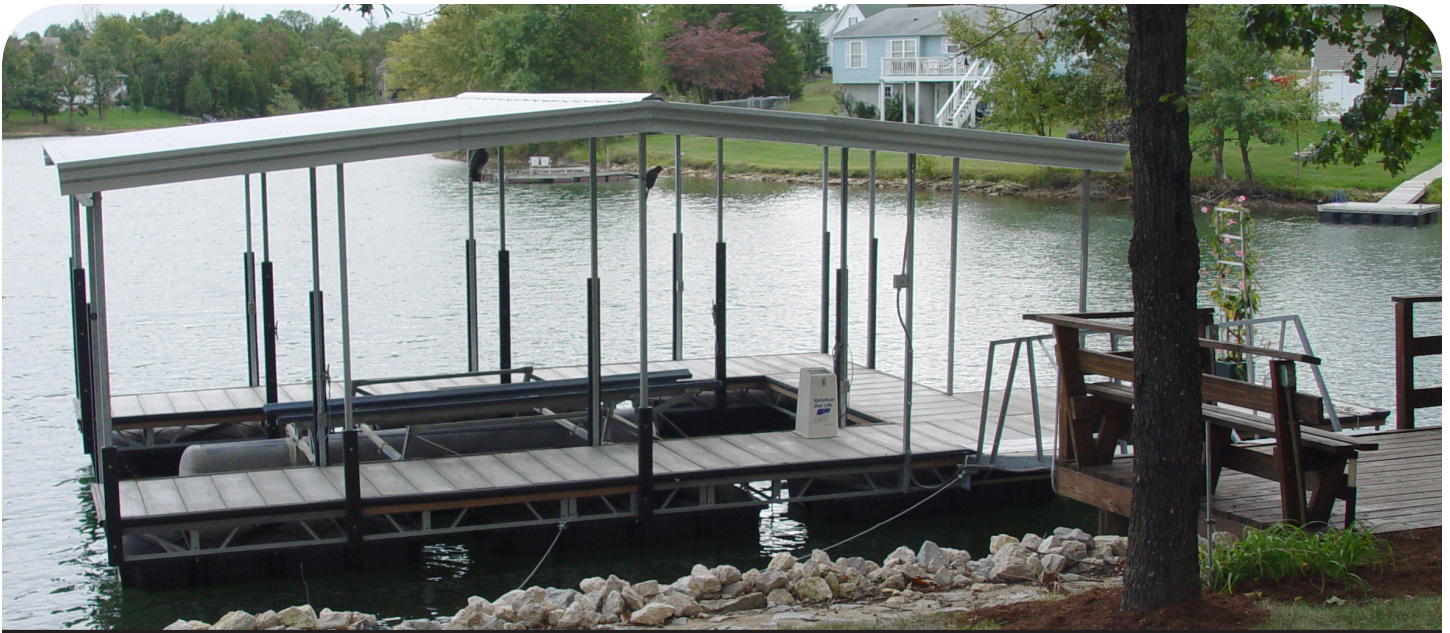
Photo 1. After conducting a forensic investigation and analysis, the electrical engineering expert on this case determined that the dock wiring was not the cause of electric currents in the lake water.

After numerous investigations by myself and other experts, we concluded that the dock wiring was not the cause of the electric currents in the lake water (**Photo 1**). However, I later discovered that the electric utility had major corrosion problems with the bare concentric neutrals of its high-voltage underground cables, which were buried under and around the lake where the accident occurred. To get a better idea of what a cable with a good and bad concentric neutral looks like, see **Photo 2** on page 21. Although these shots come from another case — one in which the

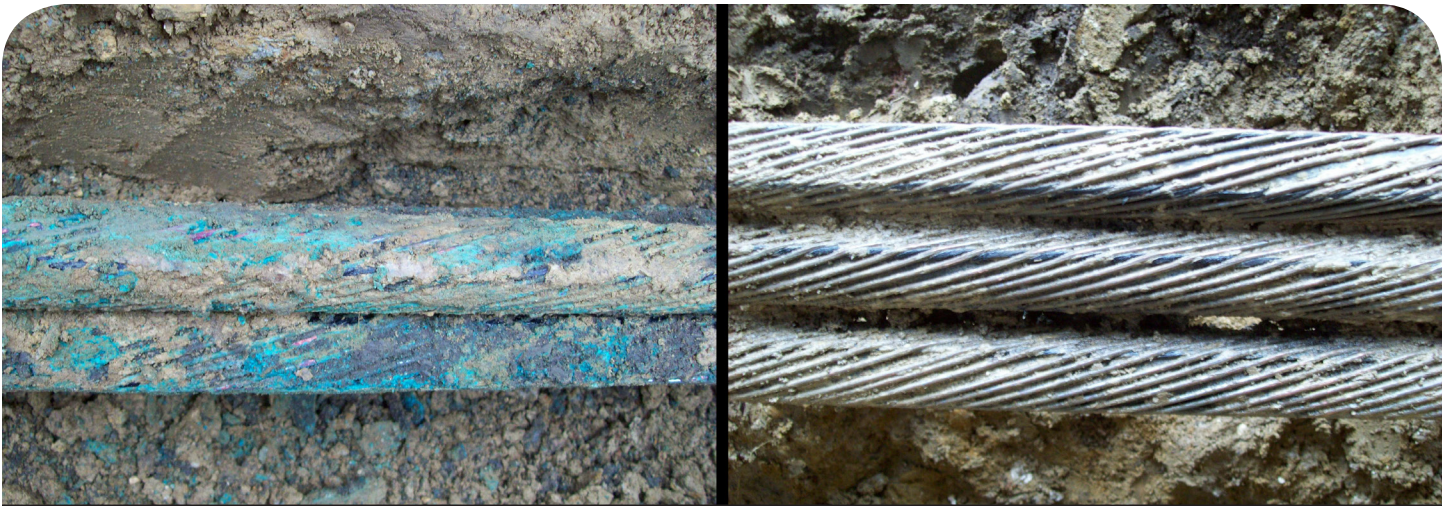
Up to nine years prior to the accident, the electric utility realized through concentric neutral testing procedures that the bare concentric neutrals were in a serious state of deterioration throughout the lake area and housing subdivision around the lake. Despite this discovery, the electric utility did not take immediate steps to fix the problem. Instead, it began a multi-year program of replacing the bare concentric neutral cables with new jacketed concentric neutral cables in the area. However, due to difficulty in installing new cable in two particular sections of

Photo 2. The images above show a badly corroded concentric neutral (left) as well as one that is in good shape (right). In the case of the bad neutral, you can see the extreme oxidation (green color) on the tin-coated copper strands.

less than one-tenth of an ampere, whereas the energized phase current was in excess of 6A. Obviously, the remainder of the return current was flowing through the earth, and, in this case, the lake water. In addition, the voltage measured from these same junction enclosures was in excess of 7V to a remote ground test point. These measurements were a clear indication that the concentric neutrals on these underground sections were likely absent due to corrosion.

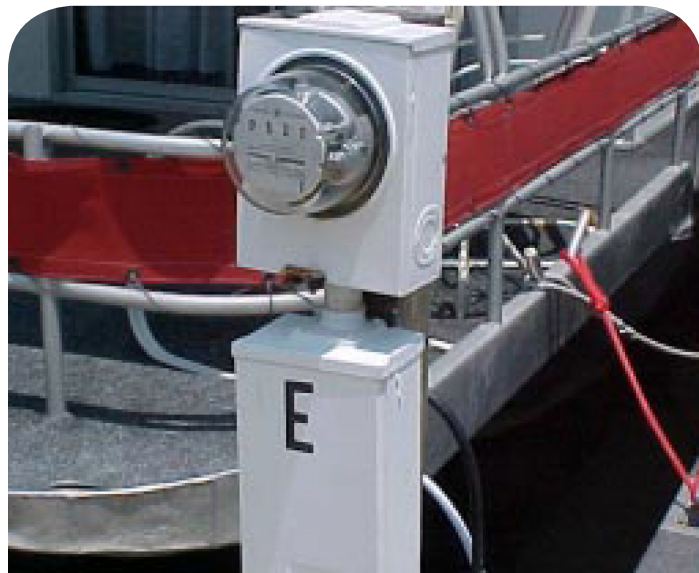
Combining electricity and water always creates the potential for danger. If the grounding system at this marina had been working properly, these deaths could have been avoided.

Since most of the problems that cause these drownings originate on the boat — and many are generated by nonqualified workmanship — it may be necessary to implement around-the-clock monitoring of the marina shore power system to detect ground faults. Such a system is available and currently in use in nine marinas.

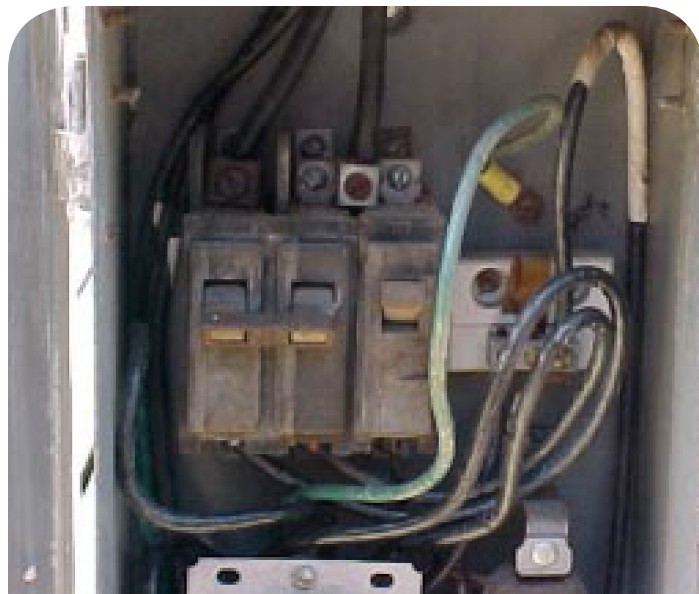
The grounding system in this dockside service panel was called into question in the investigation.

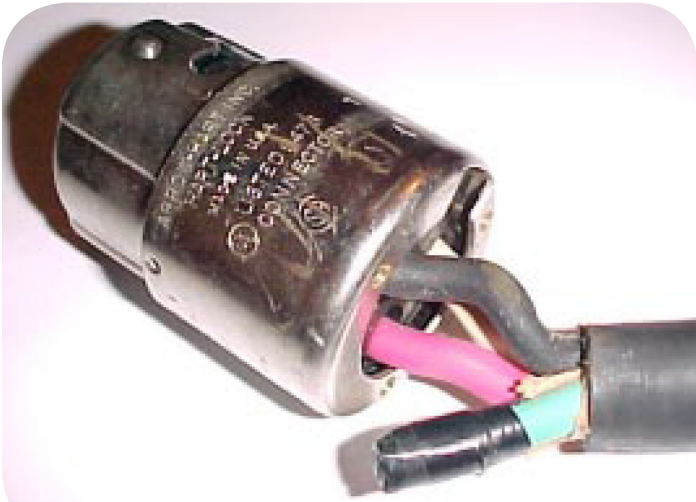
The investigation revealed that the boat owner failed to connect the grounding (bonding) wire to the female plug, which ultimately led to an ineffective ground-fault return path.

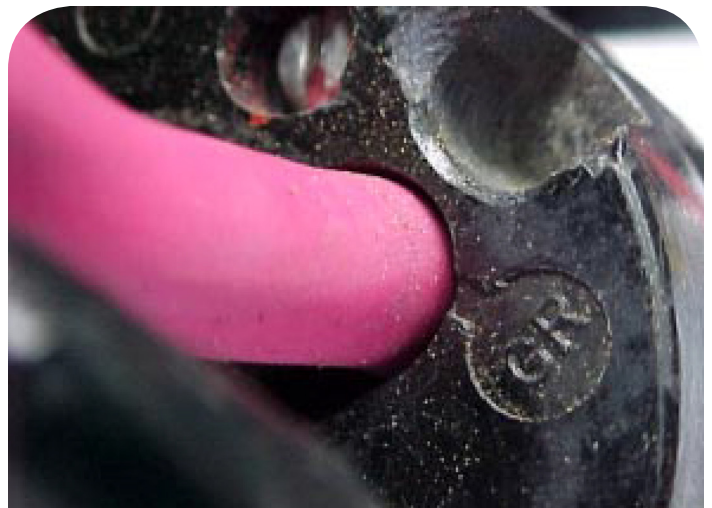
However, in making the conversion, he also altered the female plug connector at the boat. In doing so, he miswired the ground and hot wire, thus energizing the boat's aluminum hull, railing, and ladder. In addition,

Closer inspection showed that the boat owner connected a hot conductor to the ground connection.

the wiring within the boat had been altered. Additional circuits had been added, and the incoming power had been changed from 125V (as designed) to 125/250V, which had exceeded the listed rating of the houseboat's female receptacle.
