## 2000 Beneteau 411

# Pre-Purchase Report of Marine Survey

2000 Beneteau 411

**Date Of Survey:** October 28, 2024  
**Report Submitted On:** November 1, 2024

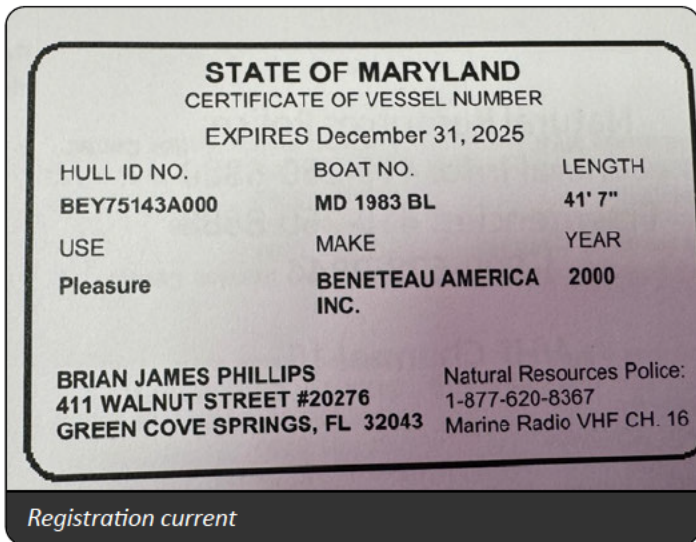
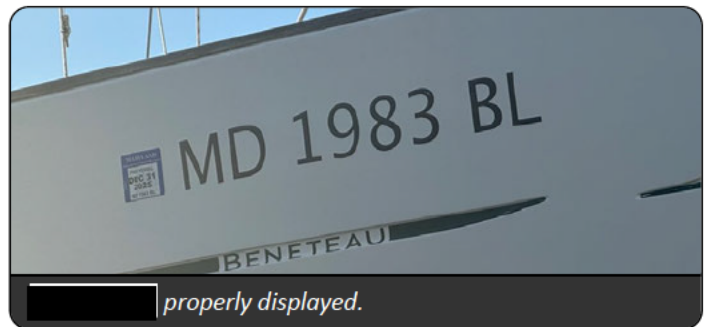
State Registration Numbers were properly displayed and the registration sticker was current.
