## 2021 28 Cutwater 28 LE

# Report of Marine Survey

2021 Cutwater 28 28 LE

**Date Of Survey:** August 30, 2024

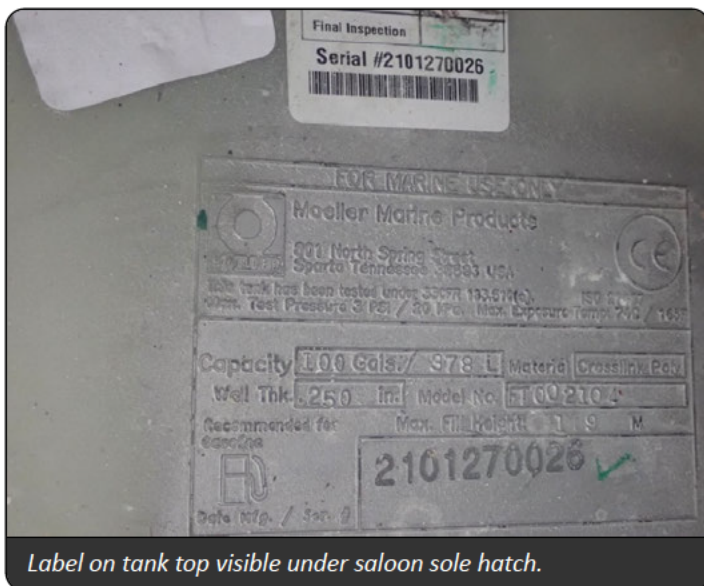
**FUEL TANK MANUFACTURER LABELING**

The manufacturer's labeling was attached and readable.

Label on tank top visible under saloon sole hatch.
